# **2006 Annual Inspection Report**

# **Barataria Bay Waterway East Bank Protection**

State Project Number BA-26 Priority Project List 6

August 10, 2006 Jefferson Parish

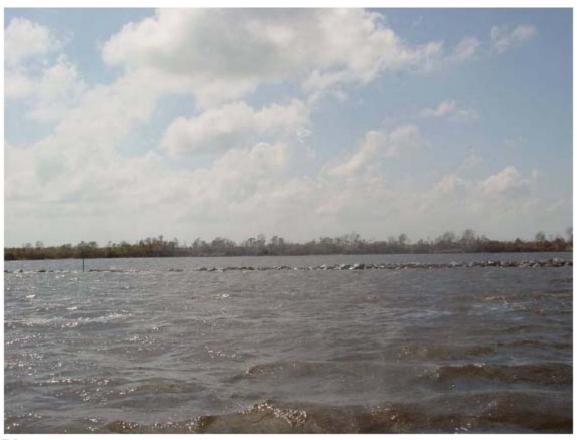
There was no noticeable damage to the rock structure due to the Hurricanes Katrina and/or Rita (Photo #1). Prior to the Hurricanes, some settlement had been noticed in the structure which was still present at the time of the inspection. In December, 2005, a contract to raise these structures was awarded and resulted in the placement of 17,417 tons of rock riprap on the settled sections of the structure. The work was completed on January 24, 2006 (Photo #2).

<u>Photo #1 – Shoreline Protection.</u> Before Maintenance Project.

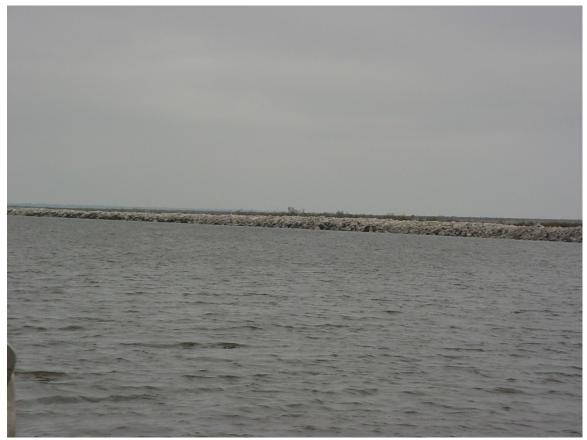
The Barataria Bay Waterway East Protection Project (BA-26) is performing as intended. The rock dike is protecting the existing marsh as designed. The recently completed maintenance lift raised the elevation of the settled sections of foreshore rock dike back to the original designed elevation. This should ensure that the structure performs adequately through the next programmed maintenance lift in 2011.

Photo No. 2 – Shoreline Protection. After Maintenance Project.
